Improving Traffic Safety for KM 212 on the Palembang-Jambi Cross Road, Musi Banyuasin Regency

To cite this article: M R B Pratama 2021 IOP Conf. Ser.: Earth Environ. Sci. 771 012032

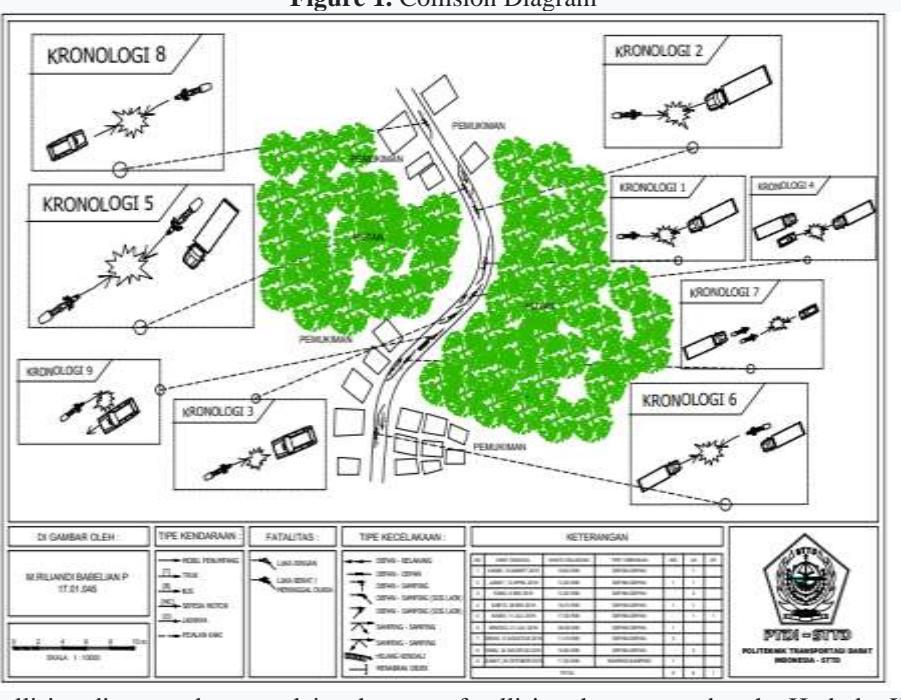
Figure 1. Collision Diagram

The collision diagram above explains the type of collision that occurred at the Harkoko KM 212 bend on the Palembang-Jambi Cross Road.

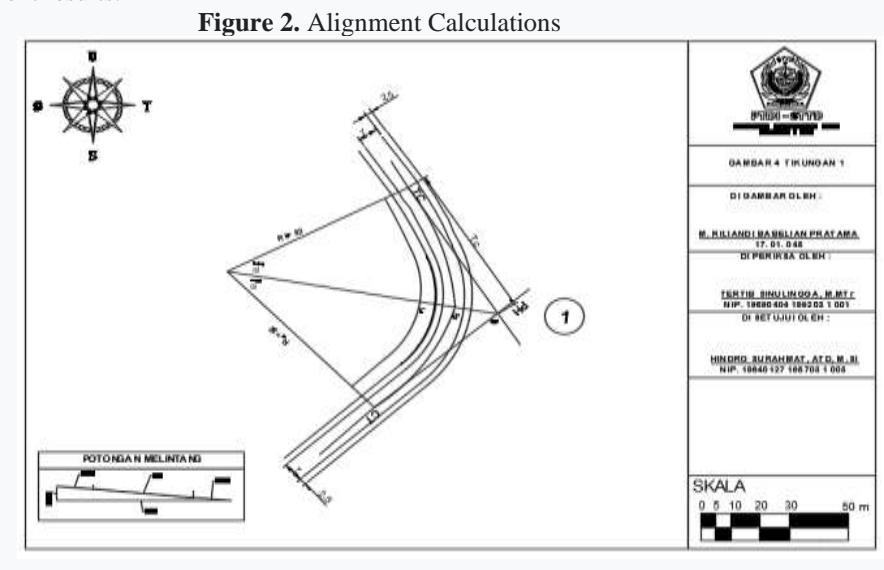
From these calculations, it can be seen the calculated speed of a vehicle and it can be concluded that the vehicle speed at the Harmoko Bend tends to have the potential to cause accidents. This is because the speed of the existing vehicle in the field (67 km/hour) is actually greater than the speed of the vehicle that should be (45 and 50 km/hour) from the calculation results based on the radius of the measurement results.
